TOWARDS SUSTAINABLE COASTAL MANAGEMENT AND DEVELOPMENT IN THREE COASTAL DISTRICTS OF BEN TRE PROVINCE

BINH DAI, BA TRI AND THANH PHU

Citation: Nguyen Tan Phong (2015). *Towards sustainable coastal management and development in three coastal Districts of Ben Tre Province (Binh Dai, Ba Tri and Thanh Phu)*. Gland, Switzerland: IUCN, 52pp.

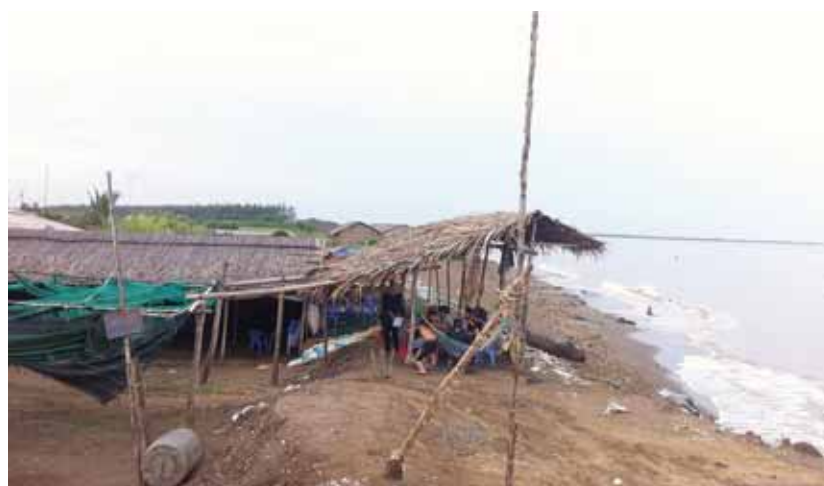
Figure 2: Simple stilt houses constructed onshore as restaurants and coffee shops to welcome local tourists on Bao Thuan coast. Ben Tre, Vietnam, Phong Nguyen, IUCN Ben Tre Project 2014

Despite being located within the Coastal Mangrove Protection Area and Special Use Forest, the coasts of Thua Duc, Thanh Hai and Bao Thuan communes have been intensively used for coastal development. Coastal development included construction of restaurants and coffee shops and tourism resorts. Simple stilt houses have been constructed as restaurants and coffee shops near the Lyrate Asian hard clam (*Meretrix lyrata*) farming areas operated by the Bao Thuan Cooperative (Figure 2), a series of restaurants were also constructed along the shoreline of Thua Duc coast (Figure 3) and on Con Bung beach of Thanh Phu District (Figure 4). High tides reach the floors of these restaurants and coffee shops. These coastal developments attract local tourists, especially on weekends.

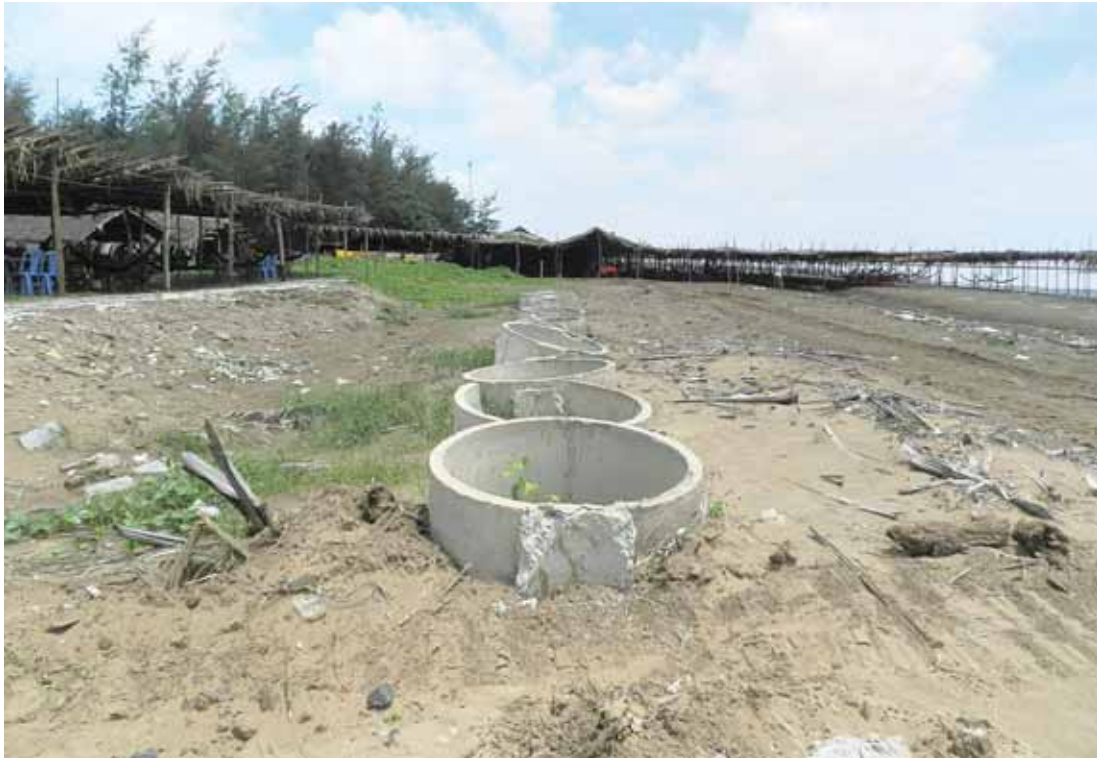
Figure 3: Many restaurants were constructed along the shoreline of Thua Duc coast to serve weekend local tourists. Ben Tre, Vietnam, Phong Nguyen, IUCN Ben Tre Project, 2014

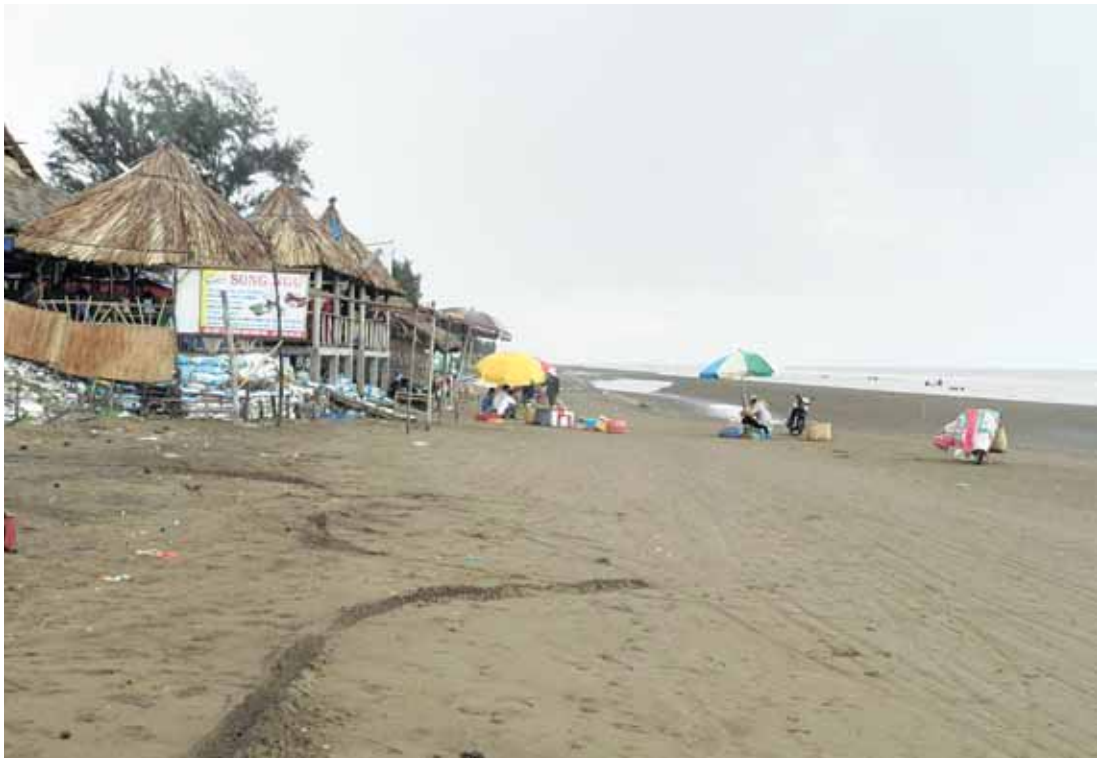
Figure 4: Many restaurants were constructed on Con Bung beach of Thanh Phu District to welcome local tourists. Ben Tre, Vietnam, Phong Nguyen, IUCN Ben Tre Project, 2014

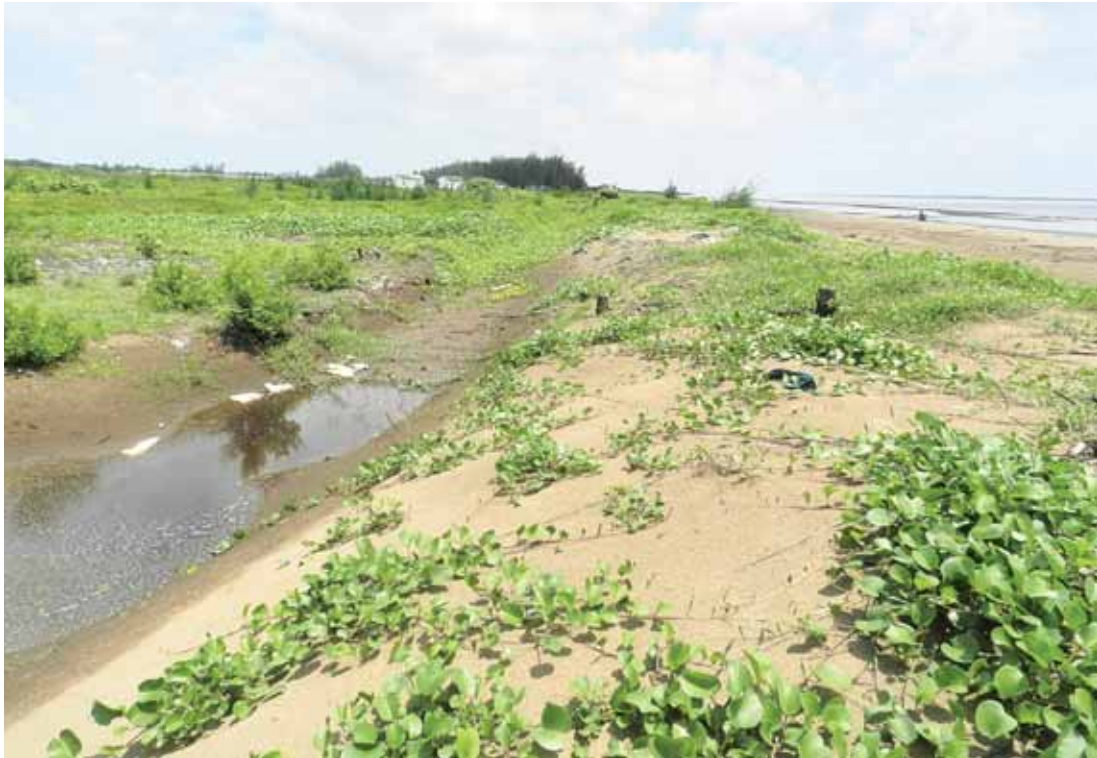
Figure 5: A large coastal area has been reserved for constructing a tourism resort on Thua Duc coast. Ben Tre, Vietnam, Phong Nguyen, IUCN Ben Tre Project, 2014

A large coastal area was reserved for constructing a tourism resort on Thua Duc coast (Figure 5). The foundation was constructed by clearing the vegetation and constructed with many concrete poles. Next to the tourism resort on the south, a large area was planned to construct a shooting ground, to be operated by the Army (Figure 6). The shooting ground construction was started by compensating those who cultivated crops on the areas.

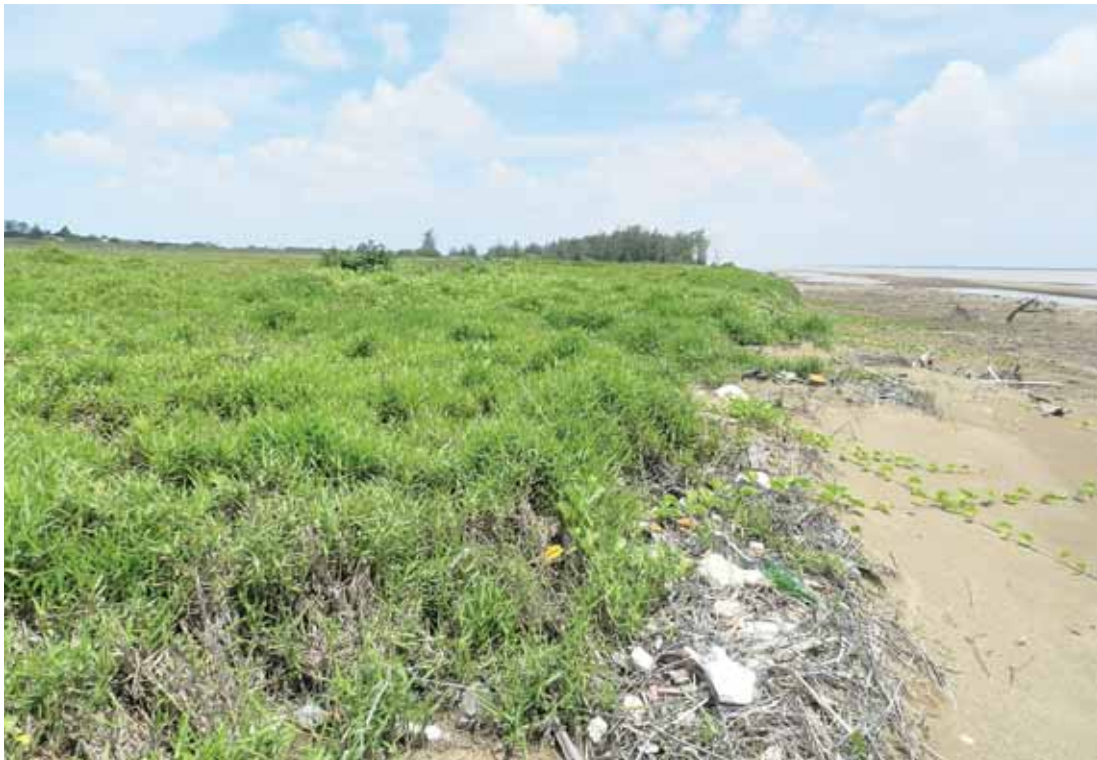
Figure 6: A large coastal area has been designated to construct a shooting ground for national defence purpose on Thua Duc coast. Ben Tre, Vietnam, Phong Nguyen, IUCN Ben Tre Project, 2014

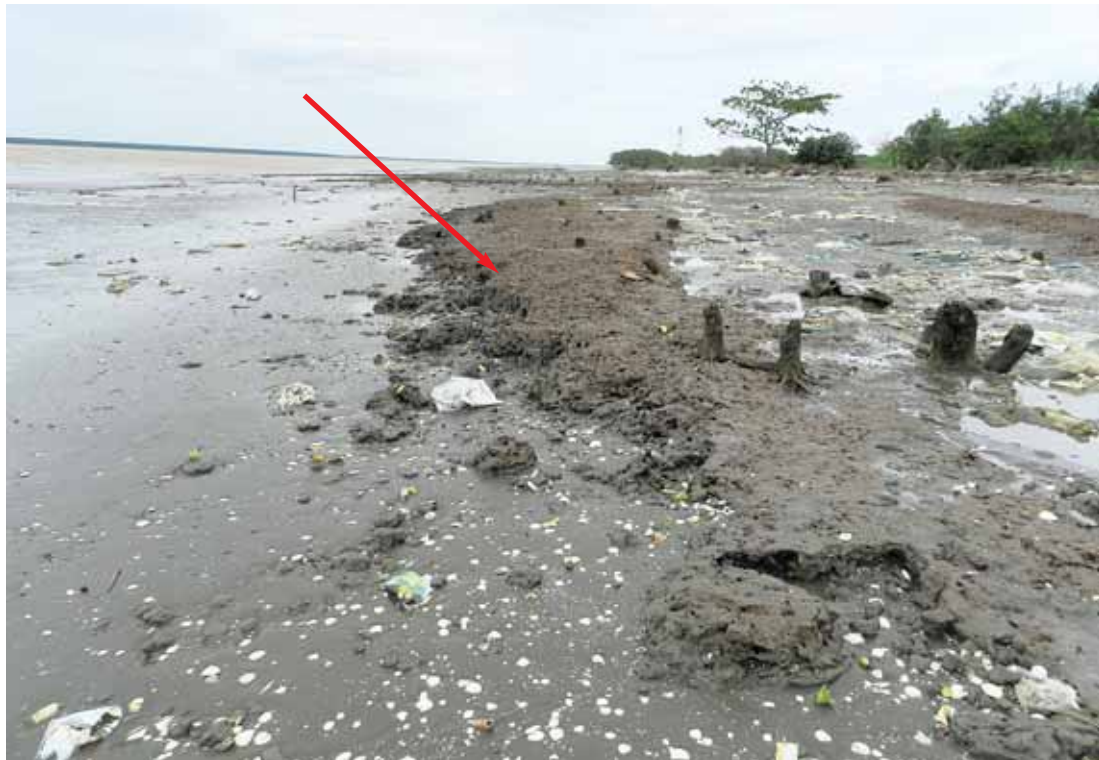
Figure 7: Remnants of pond dykes are visible on Den Chop area of An Thuy commune.
Ben Tre, Vietnam, Phong Nguyen, IUCN Ben Tre Project, 2014

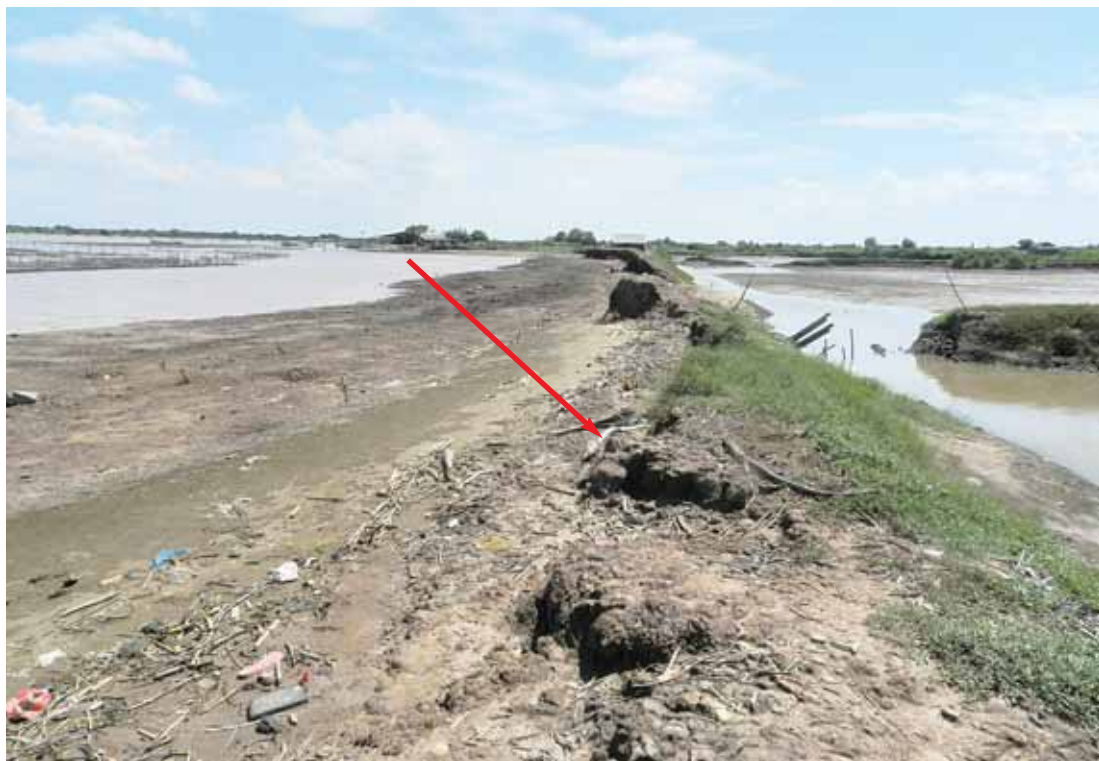
Figure 8: Remnants of pond dykes remain seen on Cong Be Lon area of Thua Duc commune.
Ben Tre, Vietnam, Phong Nguyen, IUCN Ben Tre Project, 2014

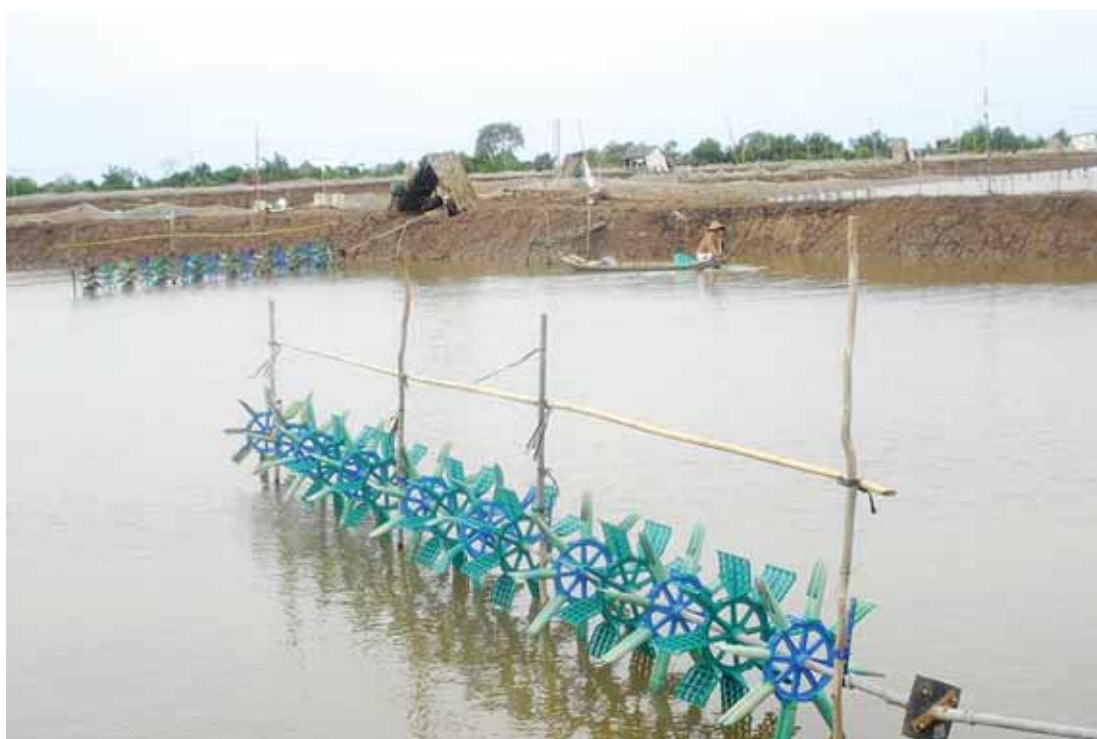
Intensive shrimp farming has recently become more common in Ben Tre, especially in Thanh Phu District. Sand dunes located among the coastal mangroves were illegally exploited for constructing ponds that were used for intensive shrimp farming (*Figure 9*). In some areas, saline water was pumped into ponds. Wells were drilled to obtain underground saline water to be supplied to ponds located further inland from the sea.

Figure 9: A sand dune area was exploited for constructing shrimp ponds in Thanh Hai commune. Electricity engines were used to start paddles to aerate shrimp farming pond water. Ben Tre, Vietnam, Phong Nguyen, IUCN Ben Tre Project, 2014

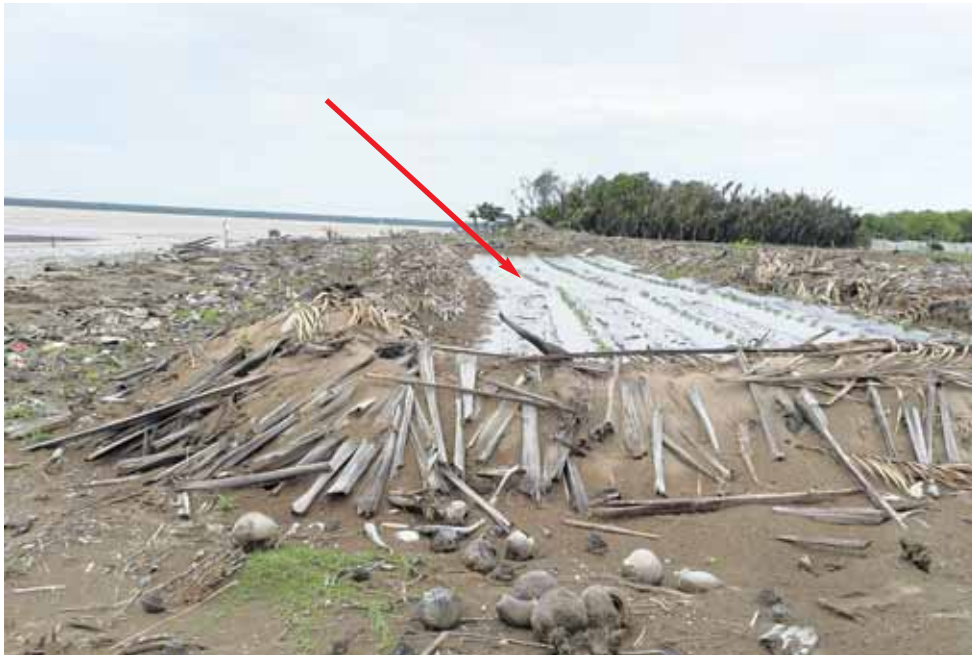
Agricultural land was created by clearing coastal mangroves and constructing bunds where agricultural crops were grown. Agricultural crops included water melon, sweet potatoes, cassava and corns. Bunds were covered with plastic sheet to retain humidity and to stop weeds (*Figure 10*). Land behind the coastal mangroves, especially sand dunes was also used for growing agricultural crops. Vegetation clearance for growing agricultural crops, either along the coasts or on sand dunes caused the coastal areas to be likely vulnerable to erosion and sand accumulation onshore. Many mature trees of *Sonneratia alba*, *Avicennia alba* and *Avicennia marina* were killed by their breath roots covered by sand in An Thuy and Thua Dua communes (*Figures 11 and 12*). At present, agricultural land, especially water melon fields are exposed to the sea due to increased coastal erosion and loss of mangroves. The exposure caused the local residents a substantial loss of crops and revenues, especially during coastal erosion, abnormally strong waves and high tides.

Figure 10: Bunds covered with plastic sheet were used to grow water melon on Den Chop area of An Thuy commune. The bunds are exposed to the sea. Ben Tre, Vietnam, Phong Nguyen, IUCN Ben Tre Project, 2014

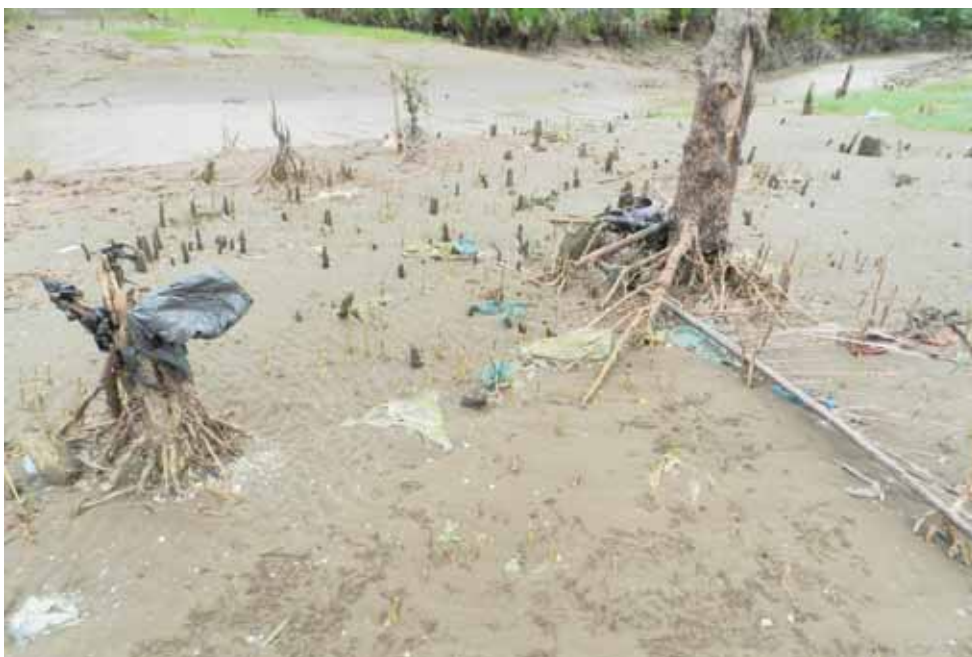
Figure 11: Mature trees of *Sonneratia alba* died on Den Chop area of An Thuy commune because their breath roots were covered by sand. Ben Tre, Vietnam, Phong Nguyen, IUCN Ben Tre Project, 2014

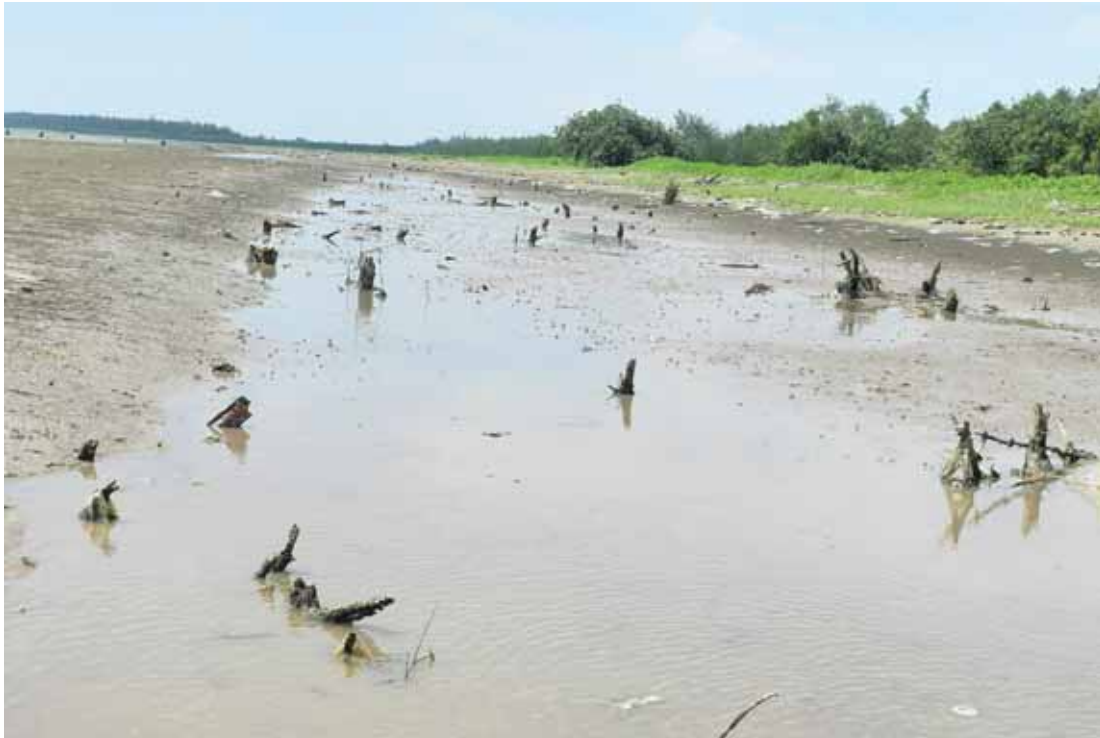
Figure 12: Mature trees of *Sonneratia alba* and *Avicennia marina* died on Cong Be Lon area of Thua Duc commune because their breath roots were covered by sand.
Ben Tre, Vietnam, Phong Nguyen, IUCN Ben Tre Project, 2014

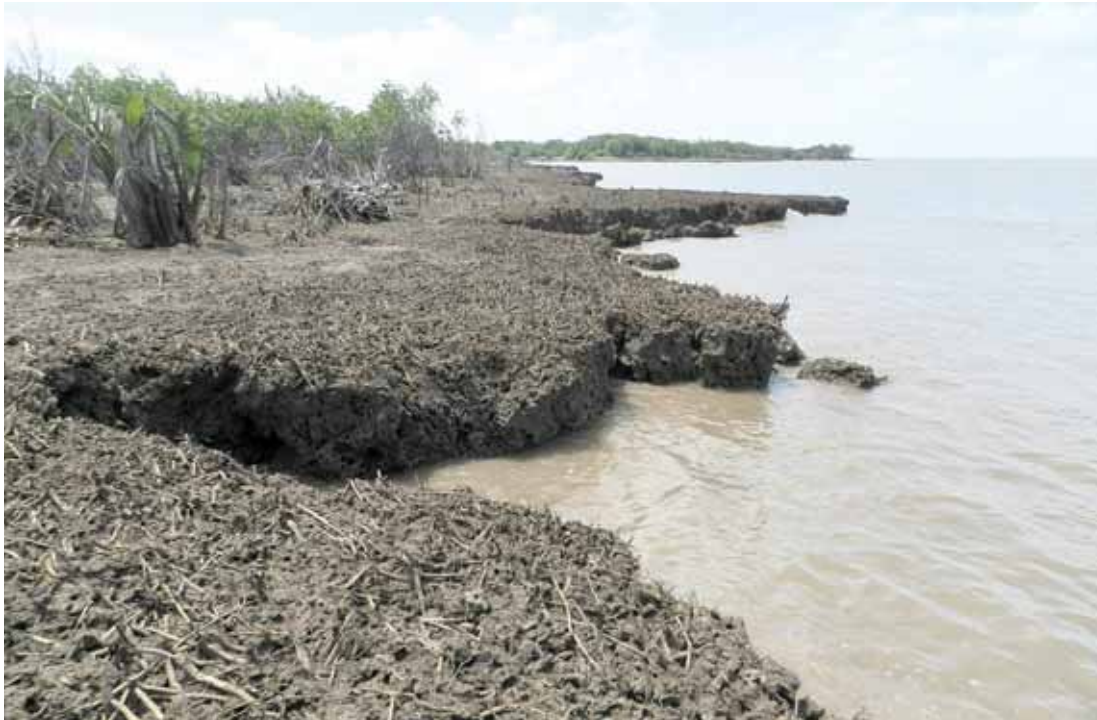
In 1997, shrimp died of unknown causes, resulting in many shrimp ponds being abandoned in Thanh Phu District. In addition, coastal mangroves along Thanh Hai coast, especially *Rhizophora apiculata* were massively destroyed in 1997 by the severe Tropical Storm Linda. Vegetation loss due to the storm combined with the abandoned ponds increased the vulnerability for coastal erosion. In Thua Duc and Thanh Hai coasts were actively eroded in 2009 and the problems became more serious between 2012 and 2013 (Figures 13, 14 and 15).

Figure 13: The coast of Cong Be Lon is actively eroding.
Ben Tre, Vietnam, Phong Nguyen, IUCN Ben Tre Project, 2014

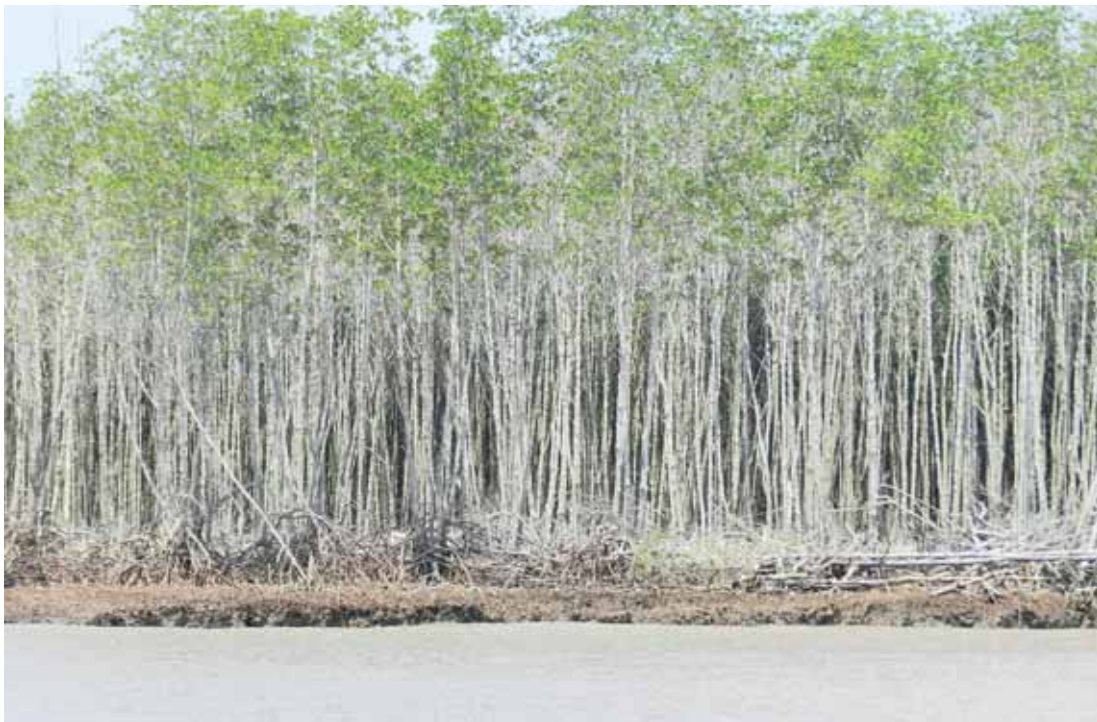
Figure 14: Cay Dua area of Thanh Hai commune is actively eroding with many mature trees of *Rhizophora apiculata* uprooted by strong waves. Ben Tre, Vietnam, Phong Nguyen, IUCN Ben Tre Project, 2014

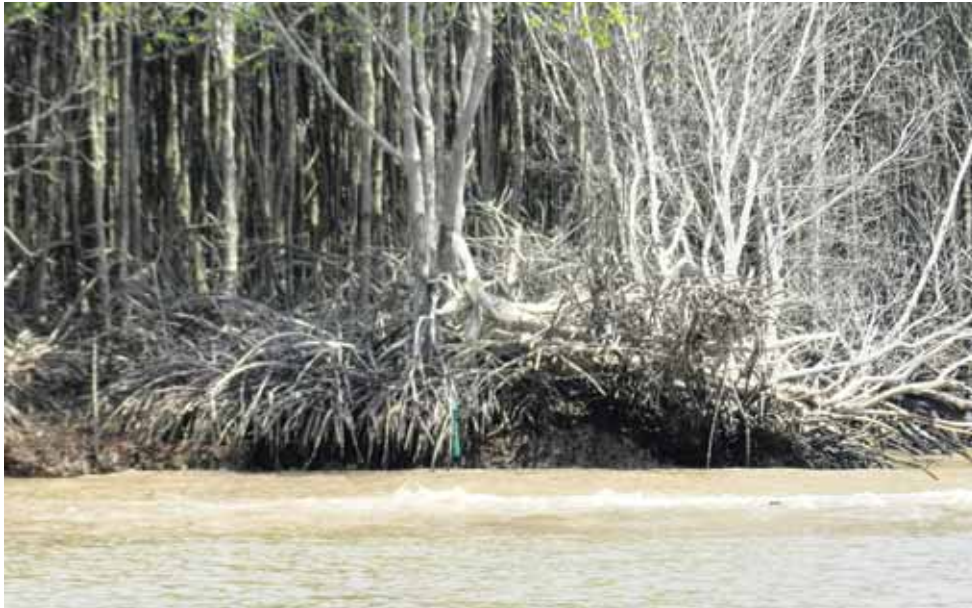
Figure 15: Many mature trees of *Rhizophora apiculata* were also uprooted by deficit of sediment around their roots on Cay Dua area of Thanh Hai commune under the influence of strong waves in high tides. Ben Tre, Vietnam, Phong Nguyen, IUCN Ben Tre Project, 2014

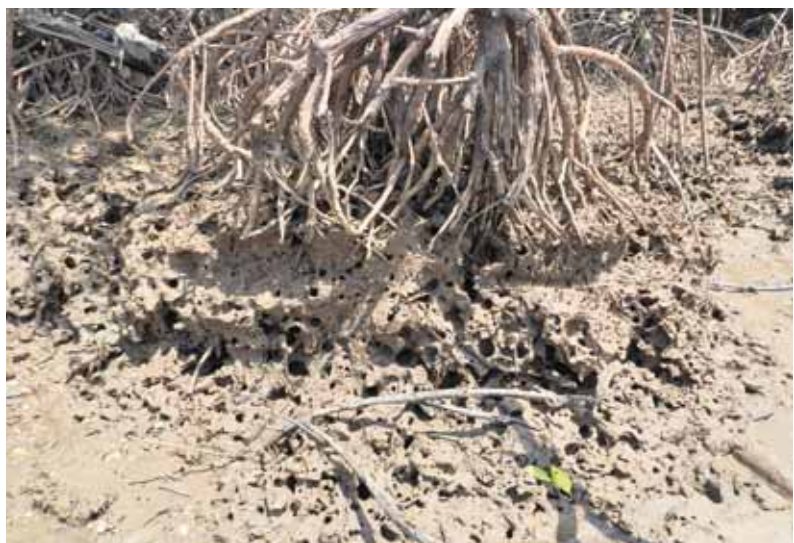
Figure 16: High burrow density was found around mature trees of *Rhizophora apiculata* in Cay Dua area, Thanh Hai commune. Ben Tre, Vietnam, Phong Nguyen, IUCN Ben Tre Project, 2014

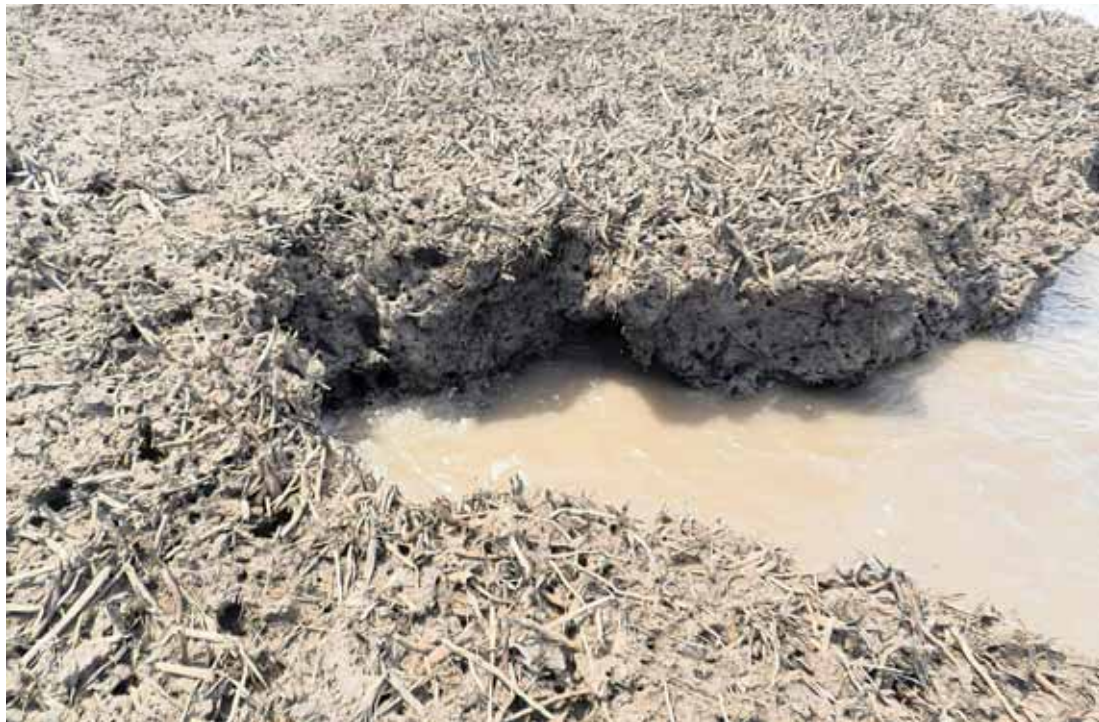
Figure 17: Burrows at a high density were found around mature trees of *Rhizophora apiculata* in Cay Dua area, Thanh Hai commune. Ben Tre, Vietnam, Phong Nguyen, IUCN Ben Tre Project, 2014

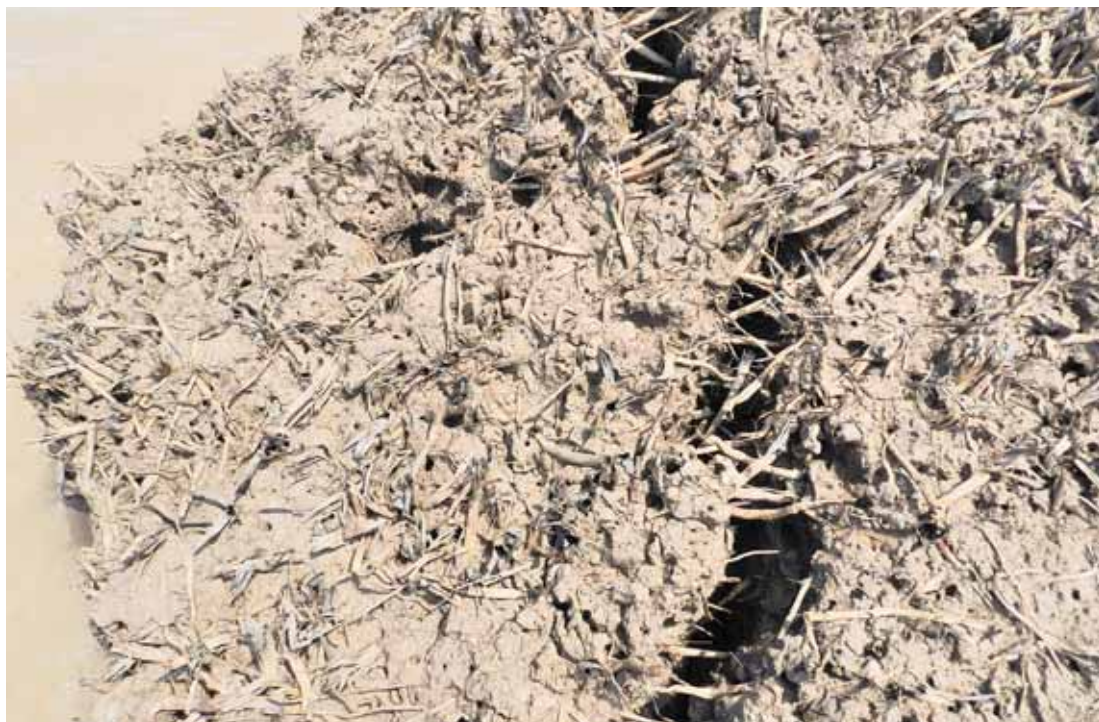
It was found that *Avicennia* species could develop strong root systems in the soil, assisting in holding the soil in place, while *Rhizophora* species spread their roots on the surface of the soil (Figure 20). Pure stands of *Rhizophora apiculata* functioned as a nursery ground where organic and inorganic nutrients were provided to commercially important fish, prawn, especially brackish water fiddlers (*Ucaminax*) (in Vietnamese *Ba Khía*) in Thanh Hai commune. Brackish water fiddlers thrived and dug burrows at high density around root areas of *Rhizophora apiculata* for making nests and protecting themselves from their predators (Figures 16 and 17). Strong waves during high tides spread into burrows, weakening the coastal soil structure and making it susceptible to collapse. Over time this has led to the coast being collapsed massively (Figures 18 and 19).

Figure 18: The coast of Cong Be Lon was massively collapsed by strong waves propagating into burrows with force. Ben Tre, Vietnam, Phong Nguyen, IUCN Ben Tre Project, 2014

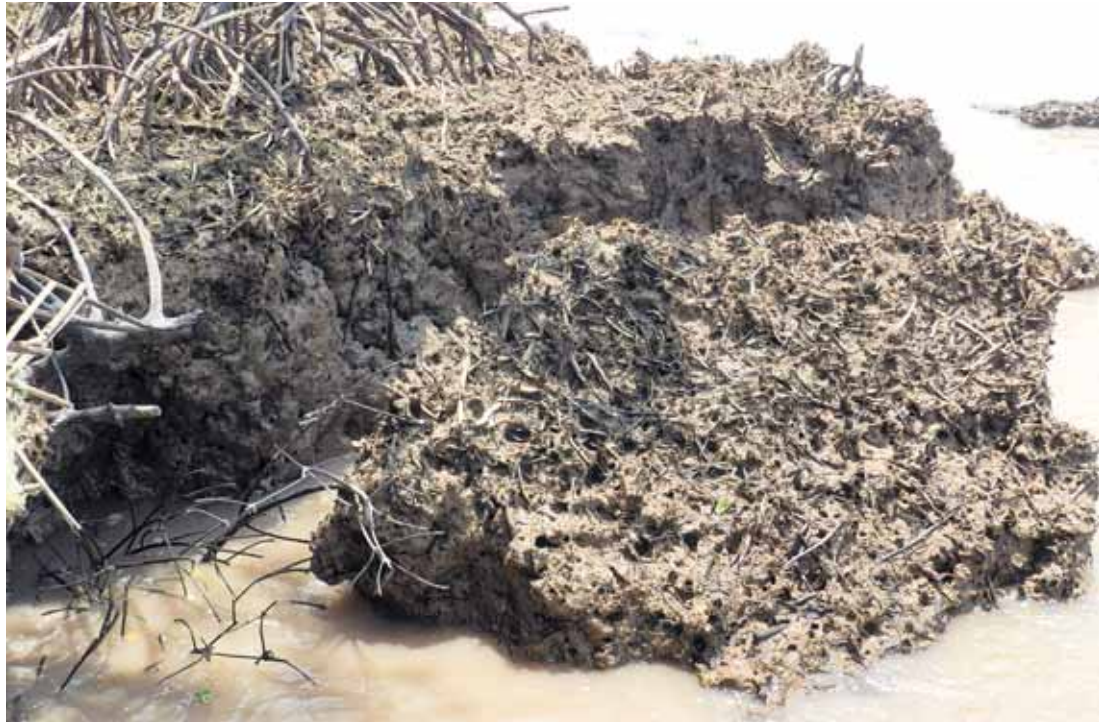
Figure 19: Strong waves propagated into burrows over time, resulting in the coast being collapsed.
Ben Tre, Vietnam, Phong Nguyen, IUCN Ben Tre Project, 2014

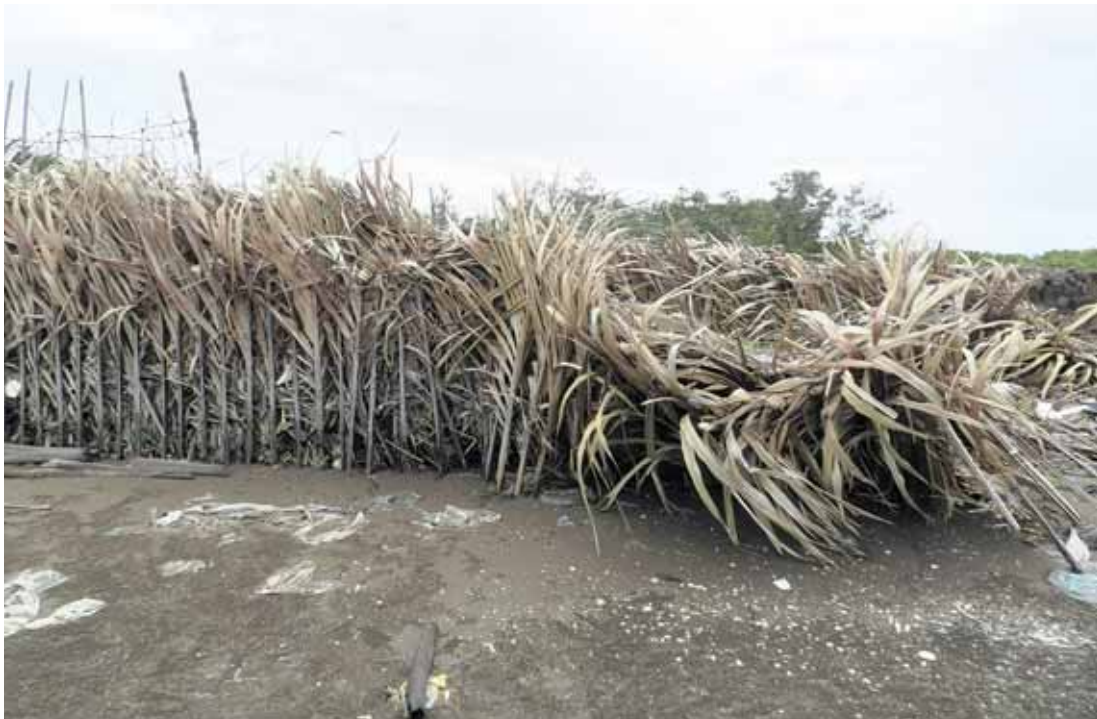
Fences were constructed by using *Nypa* leaves to protect local agricultural production land on Den Chop area of An Thuy commune, Ba Tri District, Ben Tre province. The *Nypa* leaf fences worked temporarily and were replaced every three months. The fences were weighed down by strong waves in high tides and in storms. The *Nypa* leaf fences were ineffective in the agricultural production land because they were not able to dissipate the energy of strong waves in high tides (Figure 22).

Figure 22: *Nypa* palm fence was weighed down by strong waves in high tides on Den Chop Area, An Thuy Commune. Ben Tre, Vietnam, Phong Nguyen, IUCN Ben Tre Project, 2014

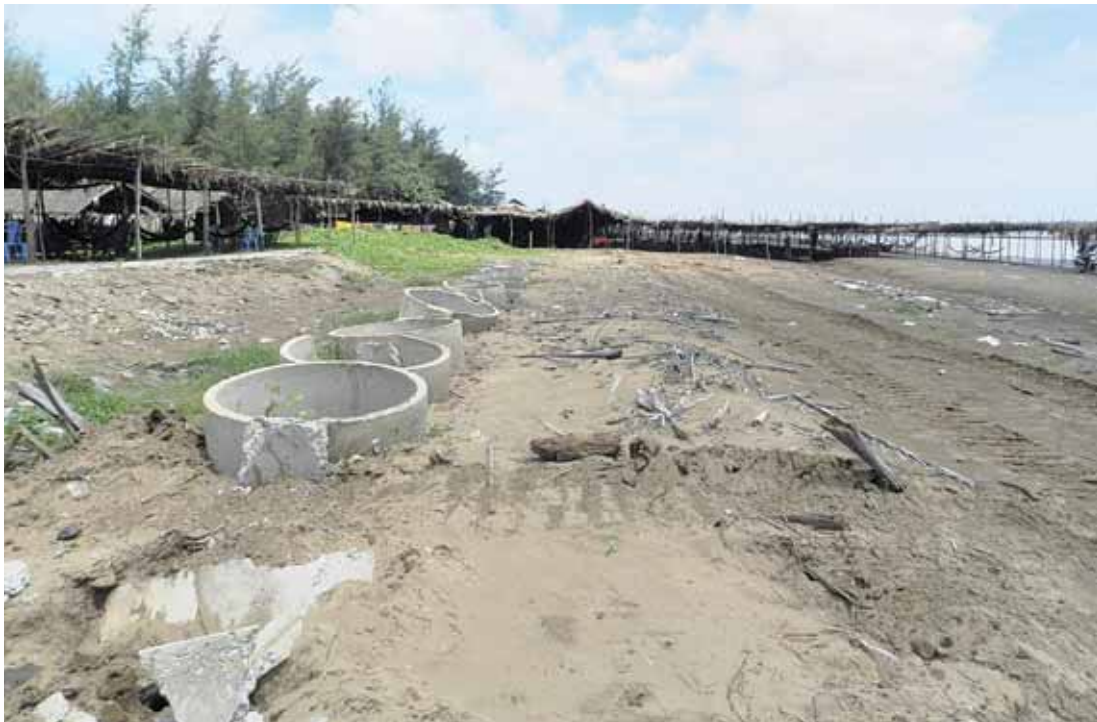
Concrete piles with diameter of 1 m were constructed to stop erosion and to protect local properties (*restaurants and agricultural land*) in Thua Duc coast (*Figure 23*). However, the concrete piles are now broken and sunk into sand and are no longer providing any benefit.

Figure 23: Broken and sunk concrete piles were seen ineffective in protecting local restaurants on Cong Be Lon area, Thua Duc commune, Binh Dai District. Ben Tre, Vietnam, Phong Nguyen, IUCN Ben Tre Project, 2014

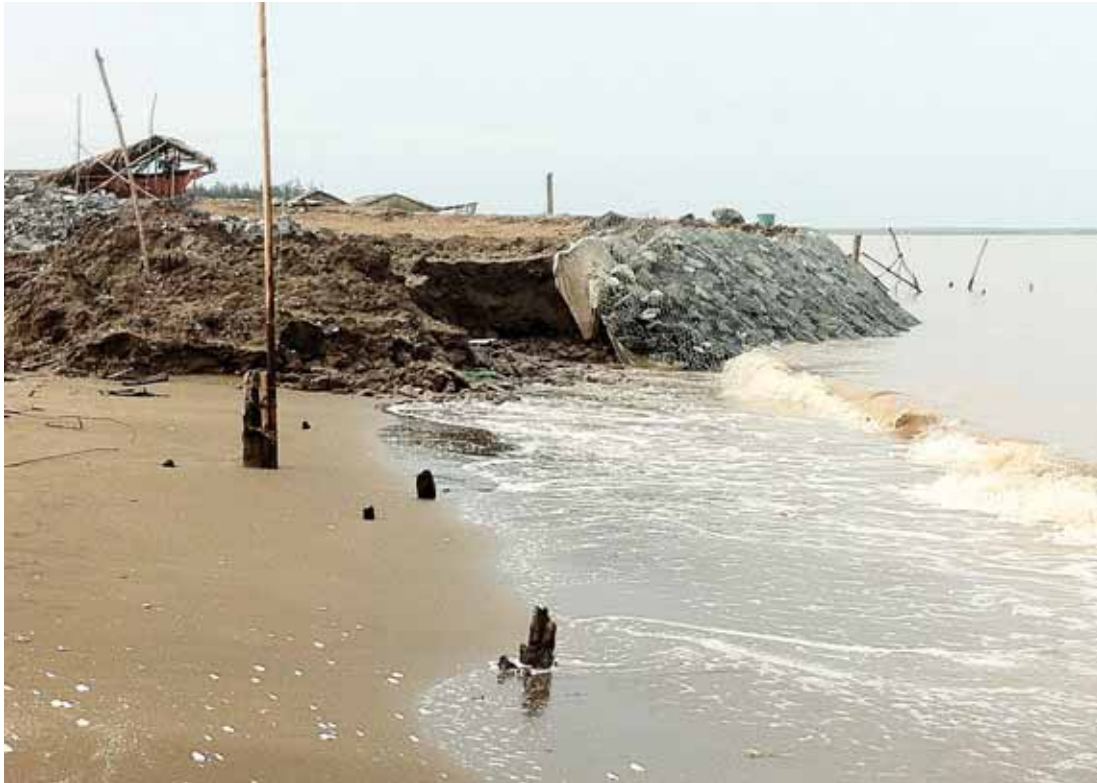
Gabion revetments were constructed by using granite rocks with protection provided by iron wires in Bao Thuan coast (*Figure 24*). Gabion revetments were constructed to protect local restaurants and public construction from erosion. However, gabion revetments were extremely expensive to construct and costly to maintain. It is unclear if gabion revetments will survive strong waves without any protection provided by other engineered or ecological engineered solutions.

Figure 24: Simply constructed but expensive gabion revetments are unsure in protecting local properties in Bao Thuan commune, Ba Tri District. Ben Tre, Vietnam, Phong Nguyen, IUCN Ben Tre Project, 2014

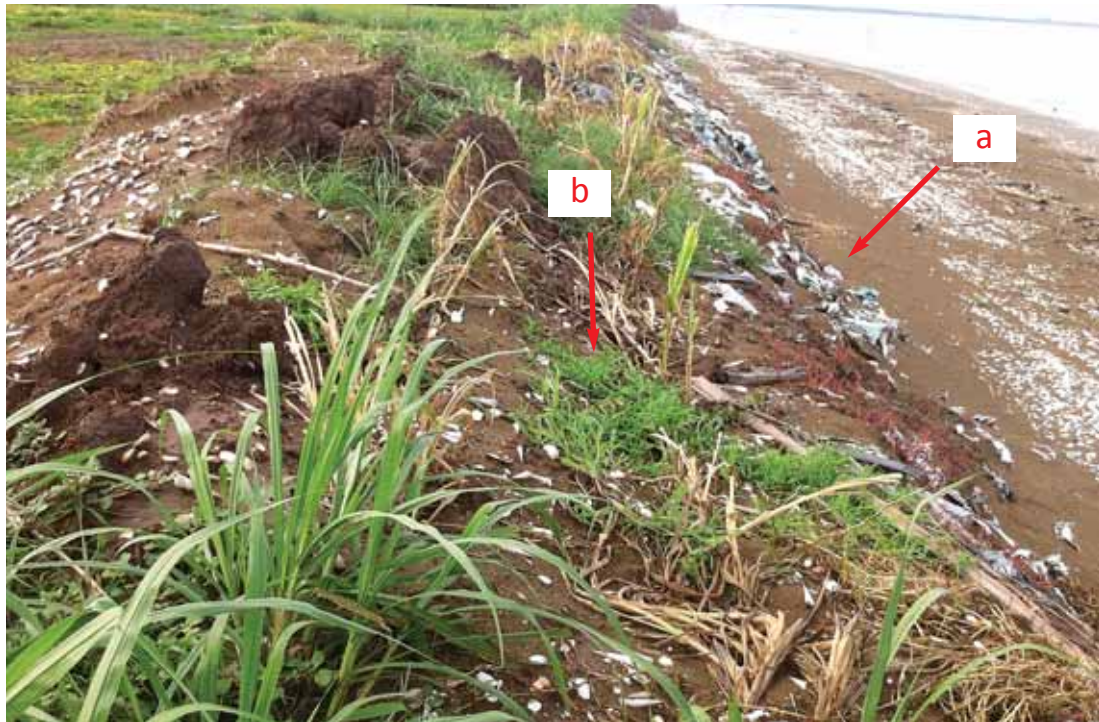
Sand bag fences are another example of coastal erosion control in Bao Thuan commune and Con Bung area of Thanh Hai commune. In Bao Thuan, bags filled with sand were piled up to construct fences to protect agricultural land. In some areas, sand bag fences were reinforced by constructing a huge soil bund on the landward side, with grasses grown on top to assist in stabilizing the soil (Figure 25). In Con Bung area, sand bag fences were constructed to protect restaurants from erosion (Figure 26). However, sand bag fences worked temporarily because the coasts in Bao Thuan and Thanh Hai have been extremely vulnerable to erosion and sand bag fences could not assist in solving coastal erosion problem themselves without any additional protection provided by other control means.

Figure 25: The photo showing sand bag fences, a) sand bag piled up to construct a fence, b) grasses were grown on topsoil behind the sand bags to reinforce the fence in Bao Thuan area. Ben Tre, Vietnam, Phong Nguyen, IUCN Ben Tre Project, 2014

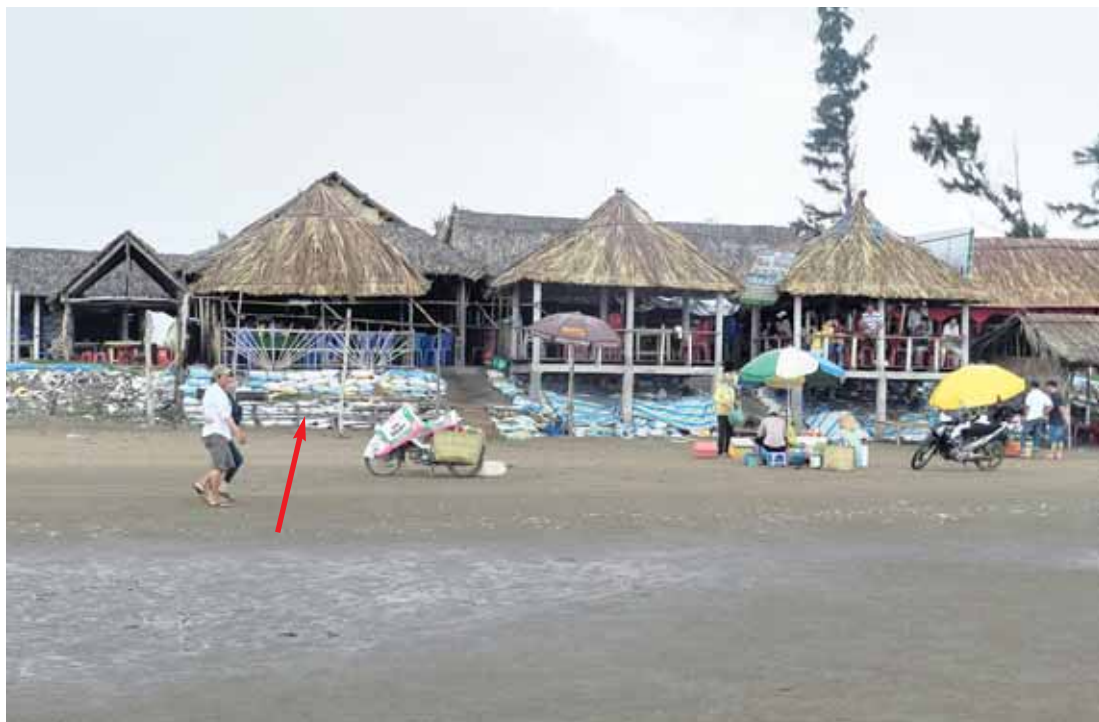
Figure 26: Bags filled with sand were piled up to construct fences to protect restaurants from erosion on Con Bung coast, Thanh Hai commune, Thanh Phu District. Ben Tre, Vietnam, Phong Nguyen, IUCN Ben Tre Project, 2014

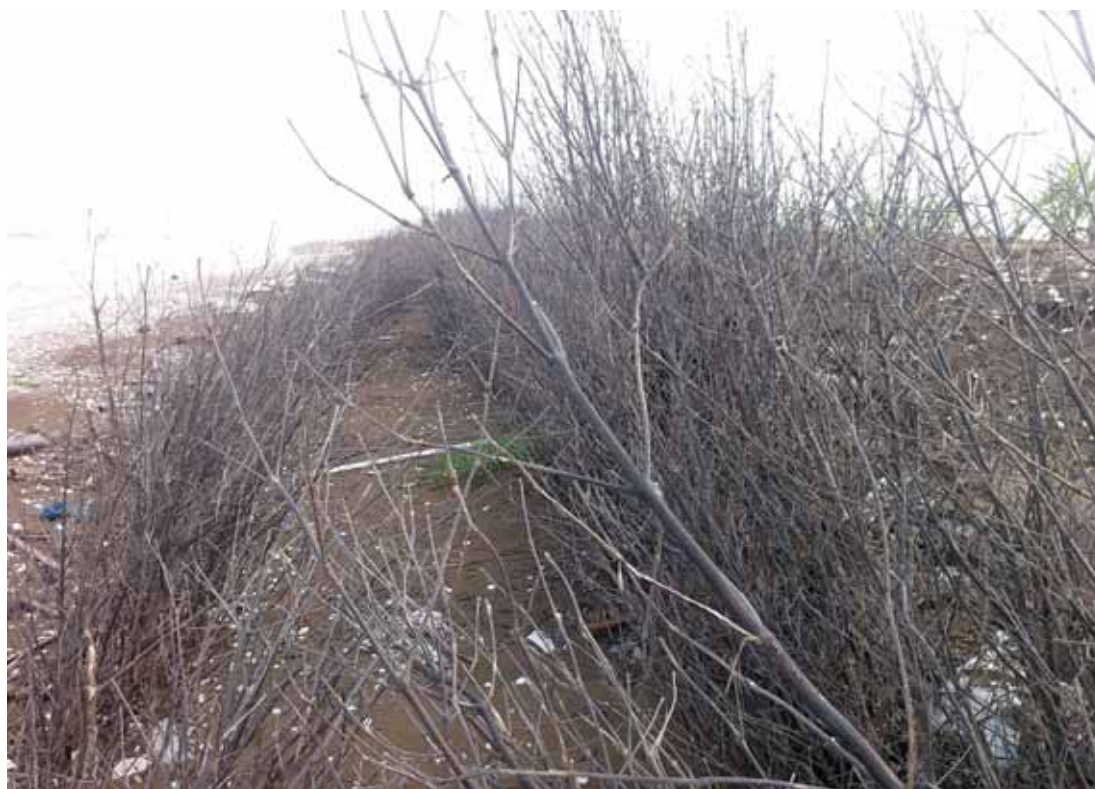
Double brush fences were constructed by using two rows of dried brushes of *Rhizophora apiculata* in parallel to the coast in Bao Thuan to protect agricultural land (Figure 27). Double brush fences did not adequately protect the land as sand was eroded by strong waves in high tides. Another form of double brush fences is reinforced double brush fences. Reinforced double brush fences were constructed by using two rows of dried brushes of *Rhizophora apiculata* with sand bags placed between two rows of dried brushes of *Rhizophora apiculata* (Figure 28). Reinforced double brush fences were also constructed in parallel to the Bao Thuan coast. These two types brush fences could not function properly without any further protection provided by other control measures.

Figure 27: Fences constructed by using two lines of dried brushes of *Rhizophora apiculata* to protect agricultural land in Bao Thuan commune, Ba Tri District. Ben Tre, Vietnam, Phong Nguyen, IUCN Ben Tre Project, 2014

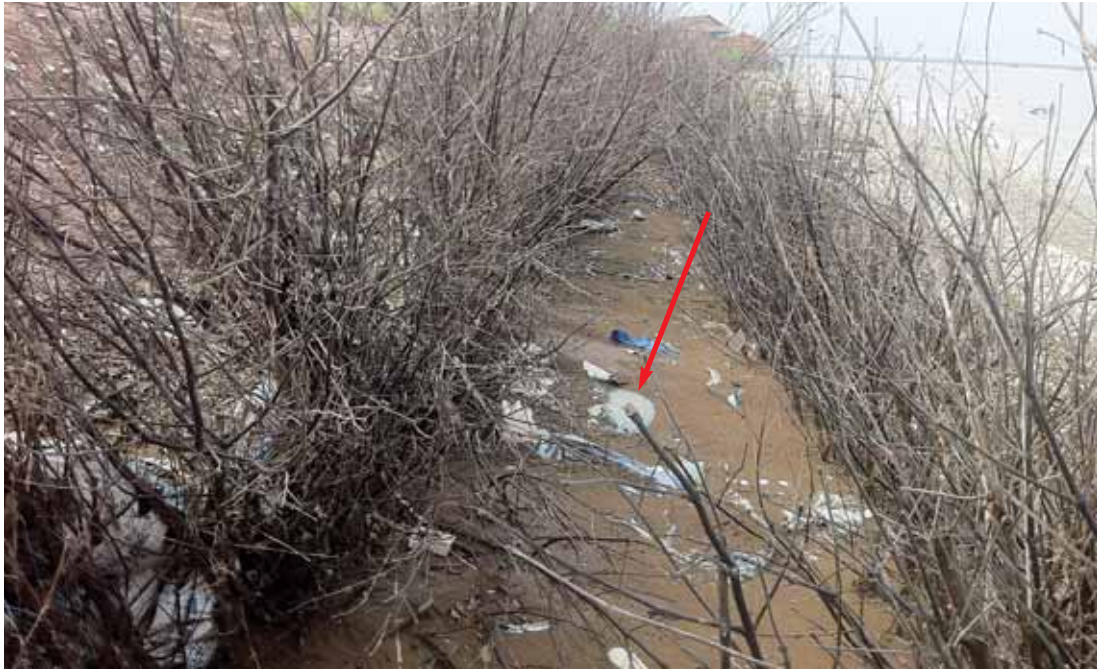
Figure 28: Double brush fences were reinforced by using sand bags placed between two lines of dried brushes of *Rhizophora apiculata* to protect agricultural land in Bao Thuan commune, Ba Tri District. Ben Tre, Vietnam, Phong Nguyen, IUCN Ben Tre Project, 2014
