TOWARDS SUSTAINABLE COASTAL MANAGEMENT AND DEVELOPMENT IN THREE COASTAL DISTRICTS OF BEN TRE PROVINCE

BINH DAI, BA TRI AND THANH PHU

Citation: Nguyen Tan Phong (2015). *Towards sustainable coastal management and development in three coastal Districts of Ben Tre Province (Binh Dai, Ba Tri and Thanh Phu)*. Gland, Switzerland: IUCN, 52pp.

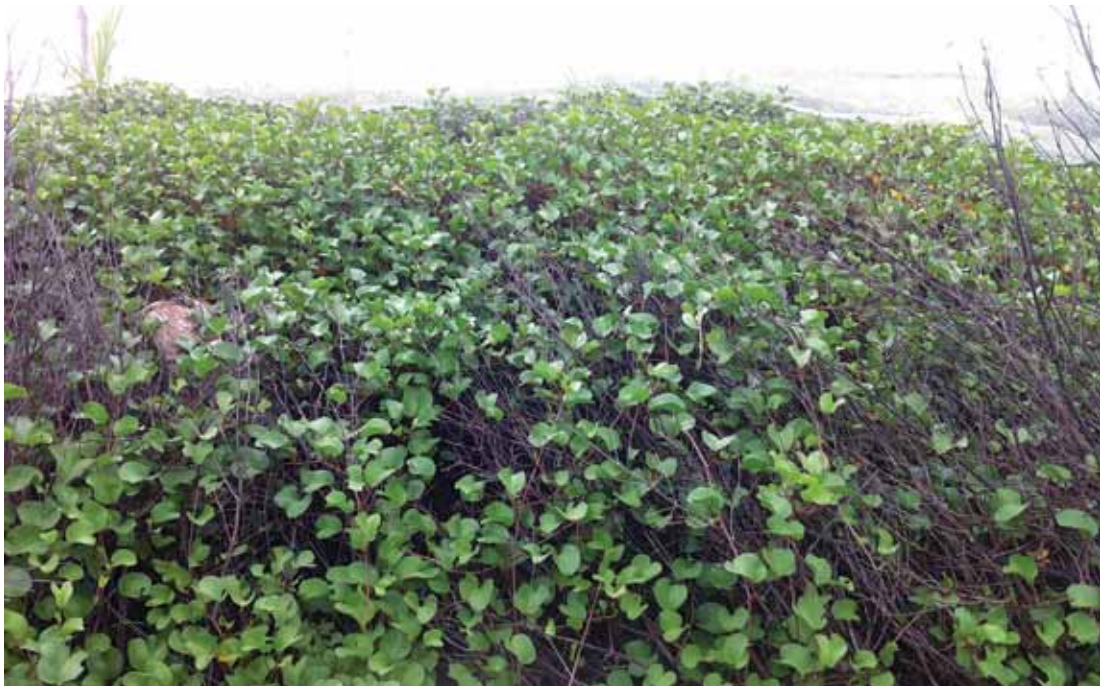
Figure 29: Beach morning glory (*Ipomoea pes-caprae*) was seen effective in stabilizing the coast in Bao Thuan commune, Ba Tri District. Ben Tre, Vietnam, Phong Nguyen, IUCN Ben Tre Project, 2014

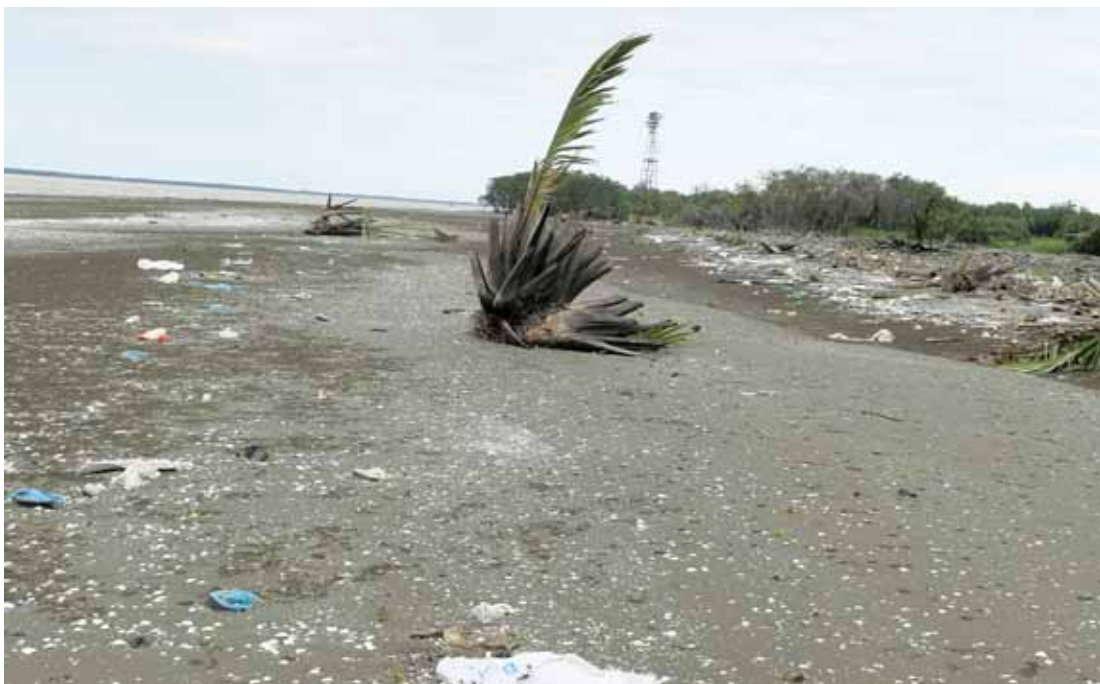
Figure 30: : Many mature trees of *Nypa fruticans* were uprooted by actively coastal erosion on Den Chop area of An Thuy commune, Ba Tri District. Ben Tre, Vietnam, Phong Nguyen, IUCN Ben Tre Project, 2014

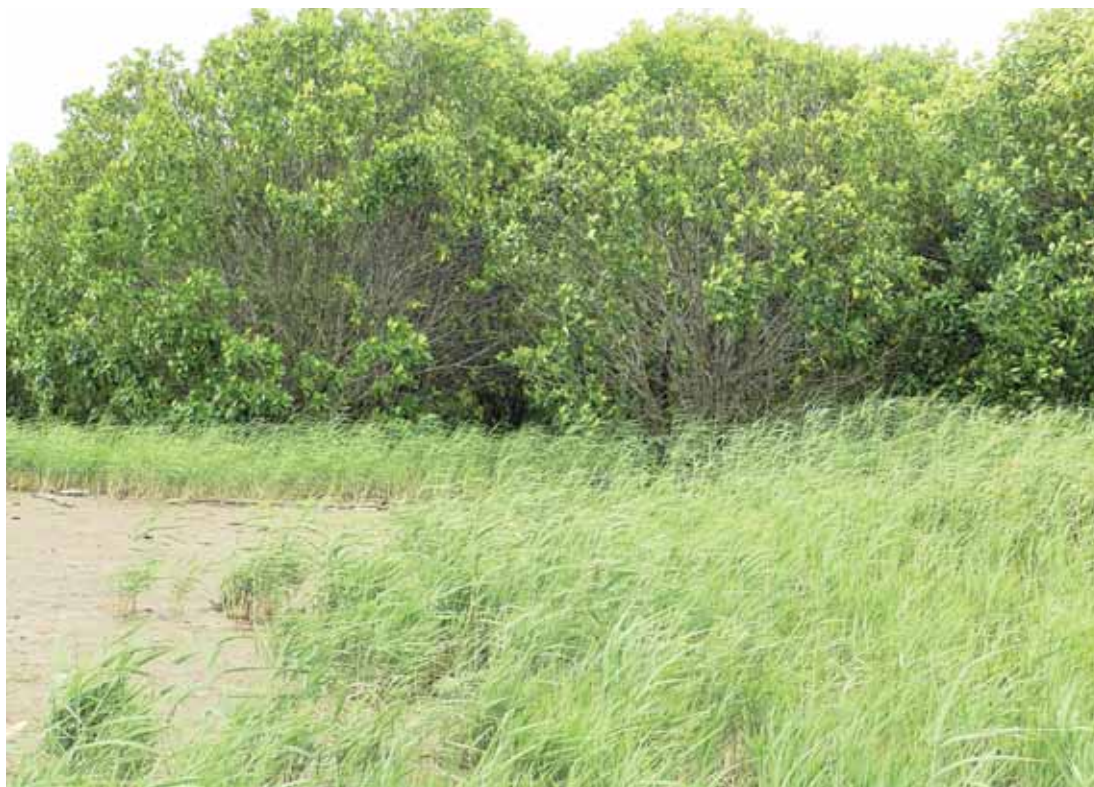
in high tides in the rainy season. An area close to the river was seen stabilized by weeds growing on sand. Weeds established a thick layer of protection, which assisted in dissipating the energy of strong waves and trapping sand and fine mud (*Figure 31*).

Figure 31: Naturally grown weeds effectively assisted in stabilizing the eroding coast on Den Chop area of An Thuy commune, Ba Tri District. Ben Tre, Vietnam, Phong Nguyen, IUCN Ben Tre Project, 2014

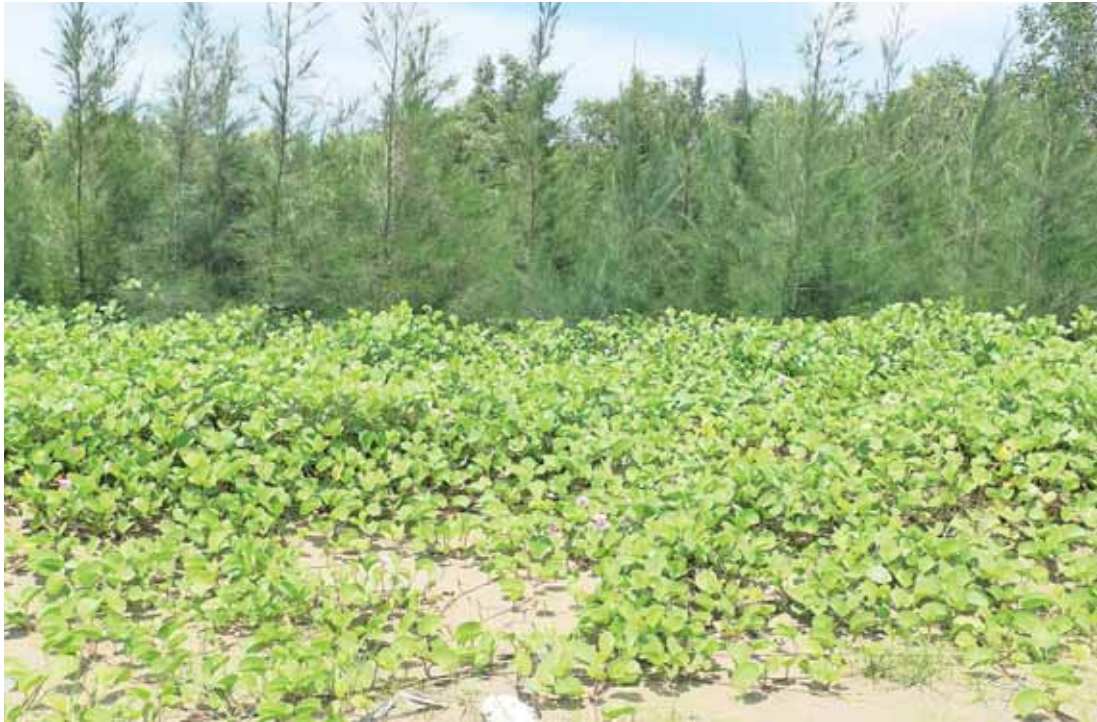
Figure 32: An area in Cong Be Lon of Thua Duc is well protected by three layers of protection, a) beach morning glory, b) planted *Casuarina* and c) mixed mangroves. Ben Tre, Vietnam, Phong Nguyen, IUCN Ben Tre Project, 2014

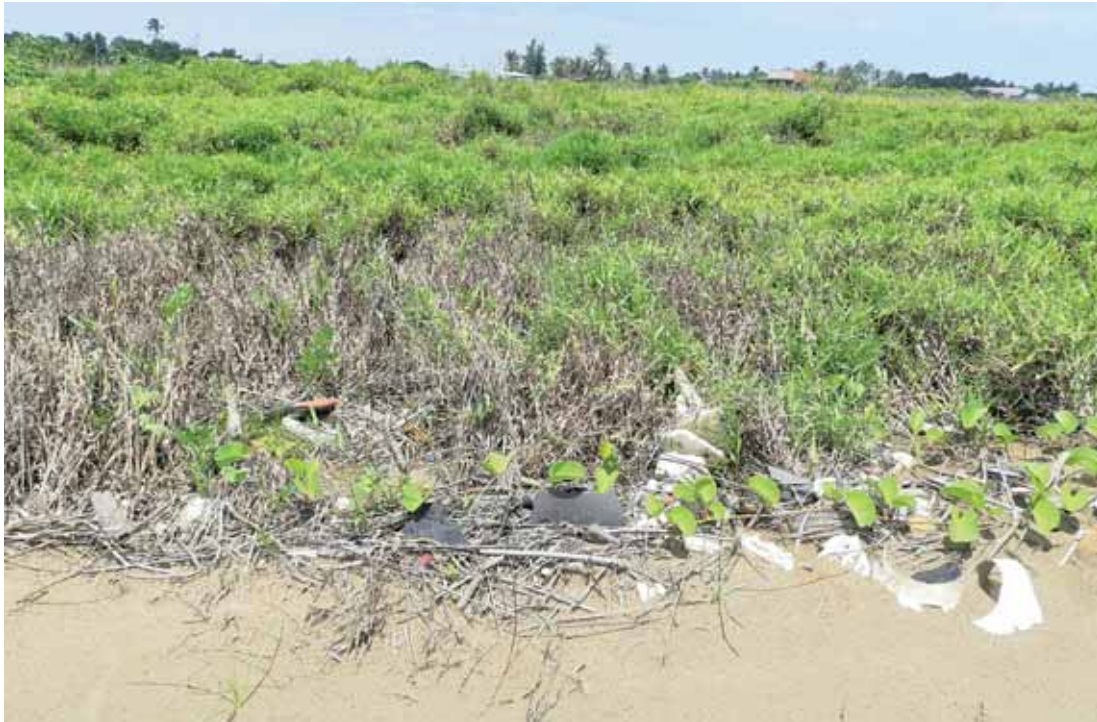
The Army's shooting ground in Thua Duc was left waste land many years ago. Weeds are growing well and have established a thick protection of the area against coastal erosion and strong waves (Figure 35). Weeds were seen effective in dissipating the energy of strong waves, especially in high tides. The area was observed effective in stopping sand accumulation and mitigating negative impacts associated with coastal erosion.

Figure 35: A very thick layer of naturally grown weeds establishes a good protection and assists in stabilizing Cong Be Lon area of Thua Duc. Ben Tre, Vietnam, Phong Nguyen, IUCN Ben Tre Project, 2014

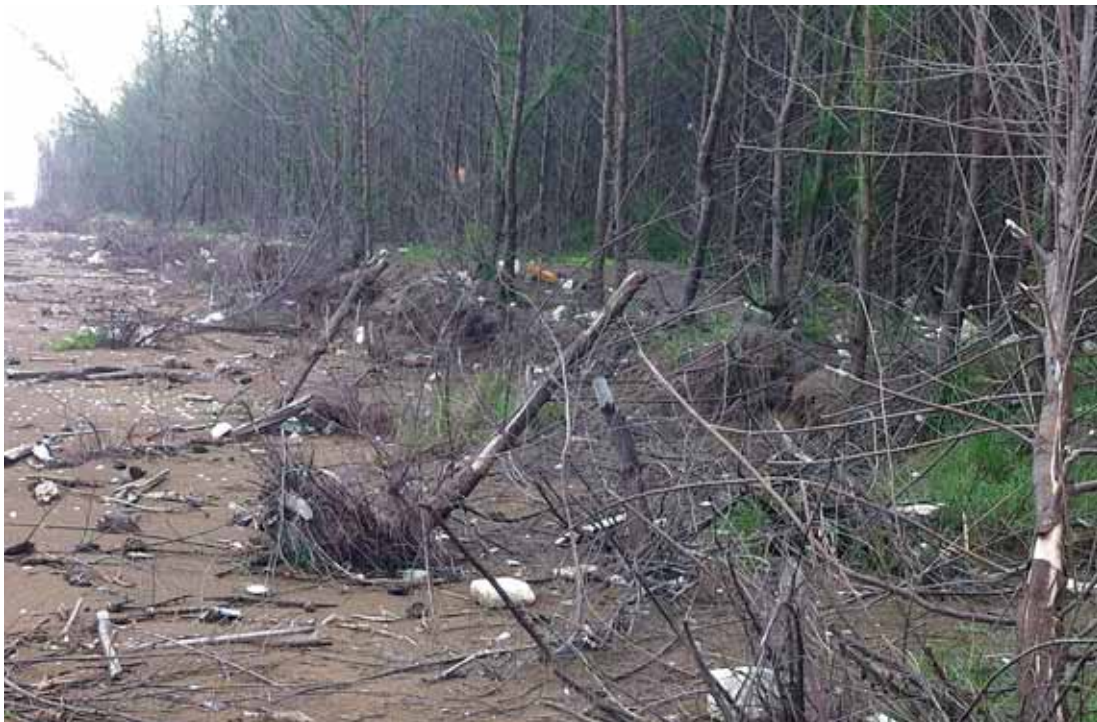
Figure 36: A large area of planted Casuarina is vulnerable to erosion in Bao Thuan. Many trees were uprooted by strong waves. Ben Tre, Vietnam, Phong Nguyen, IUCN Ben Tre Project, 2014

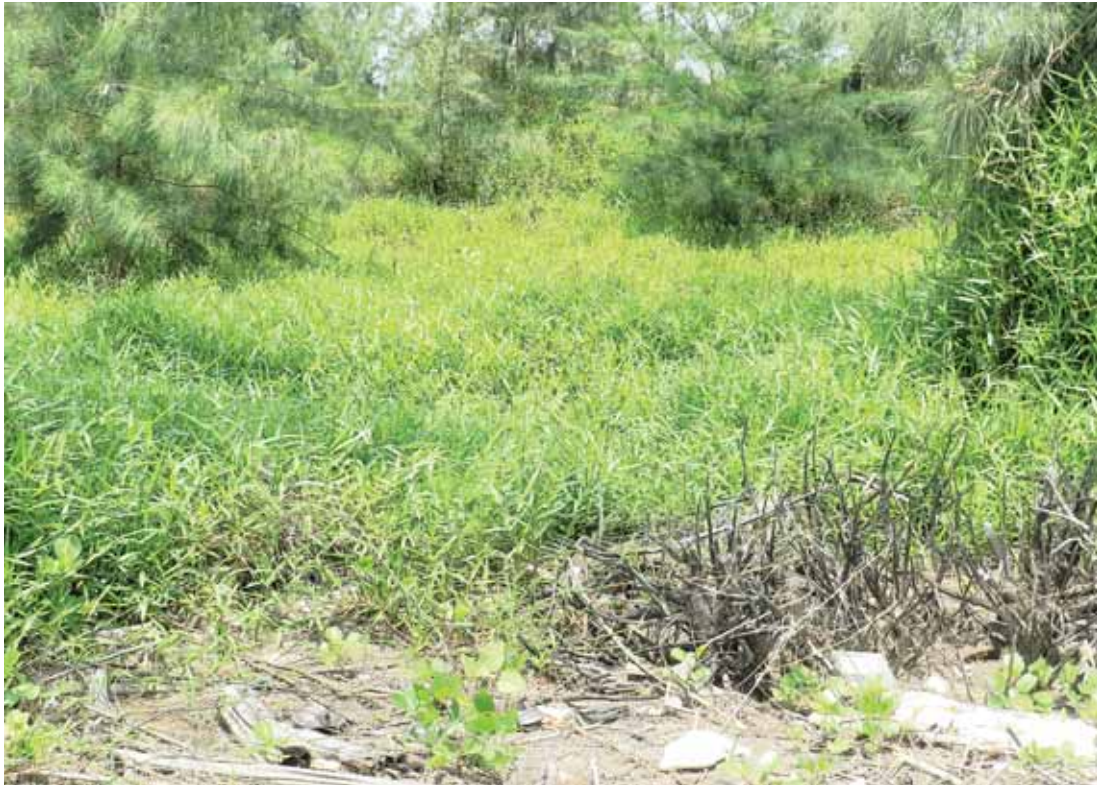
Figure 37: A fragmented area of planted *Casuarina* has been filled with naturally grown weeds that effectively assist in stabilizing the Cong Be Lon area of Thua Duc. Ben Tre, Vietnam, Phong Nguyen, IUCN Ben Tre Project, 2014

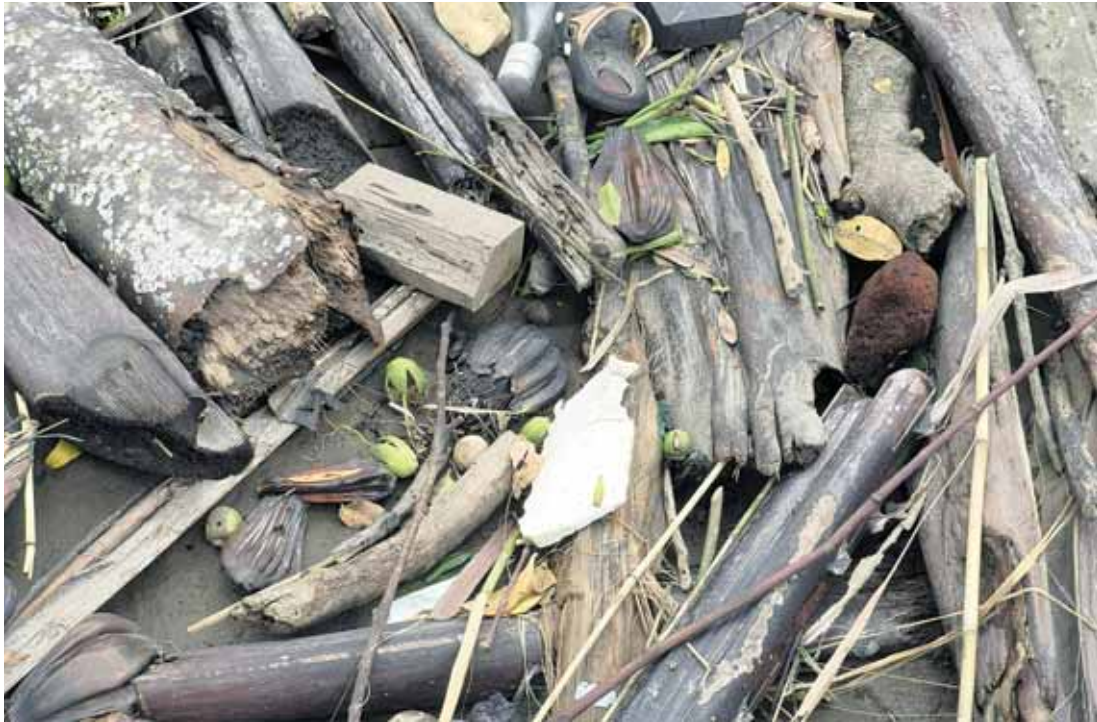
Figure 38: : Seeds transported onshore were gradually trapped by dried tree branches and fruits on Den Chop actively eroding area of An Thuy commune, Ba Tri District. Ben Tre, Vietnam, Phong Nguyen, IUCN Ben Tre Project, 2014

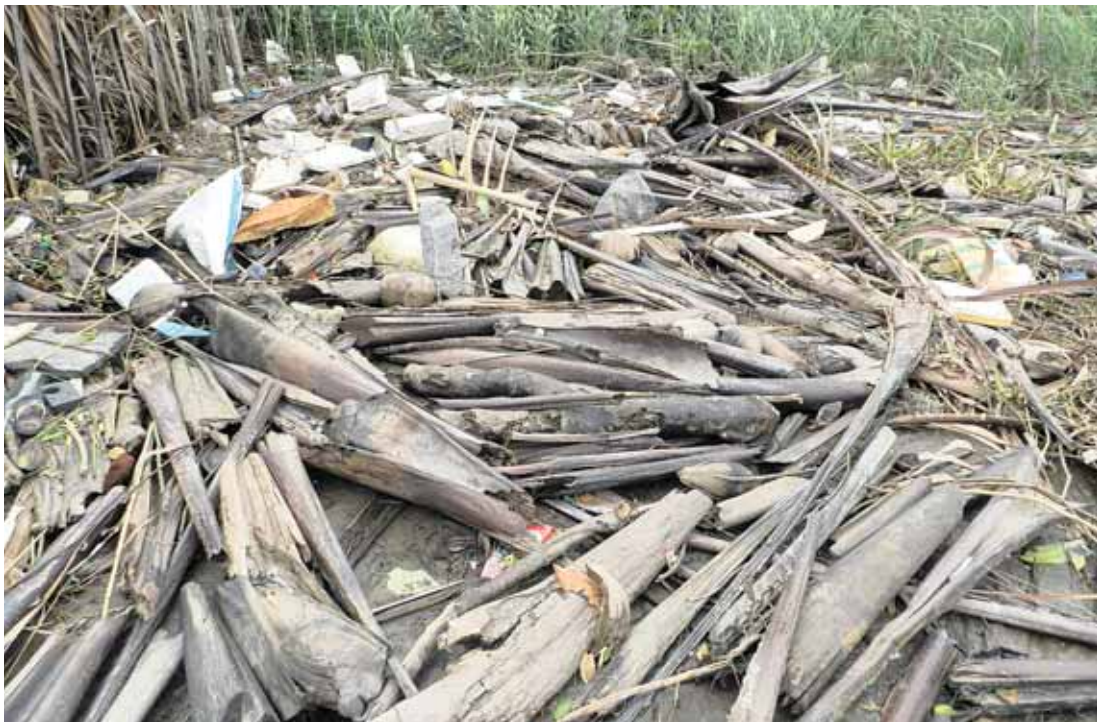
Figure 39: Dried Nypa palms and branches, plastic rubbish functioned as entrapping micro-sites that assisted in trapping seeds for natural regeneration on Den Chop actively eroding area of An Thuy commune, Ba Tri District. Ben Tre, Vietnam, Phong Nguyen, IUCN Ben Tre Project, 2014

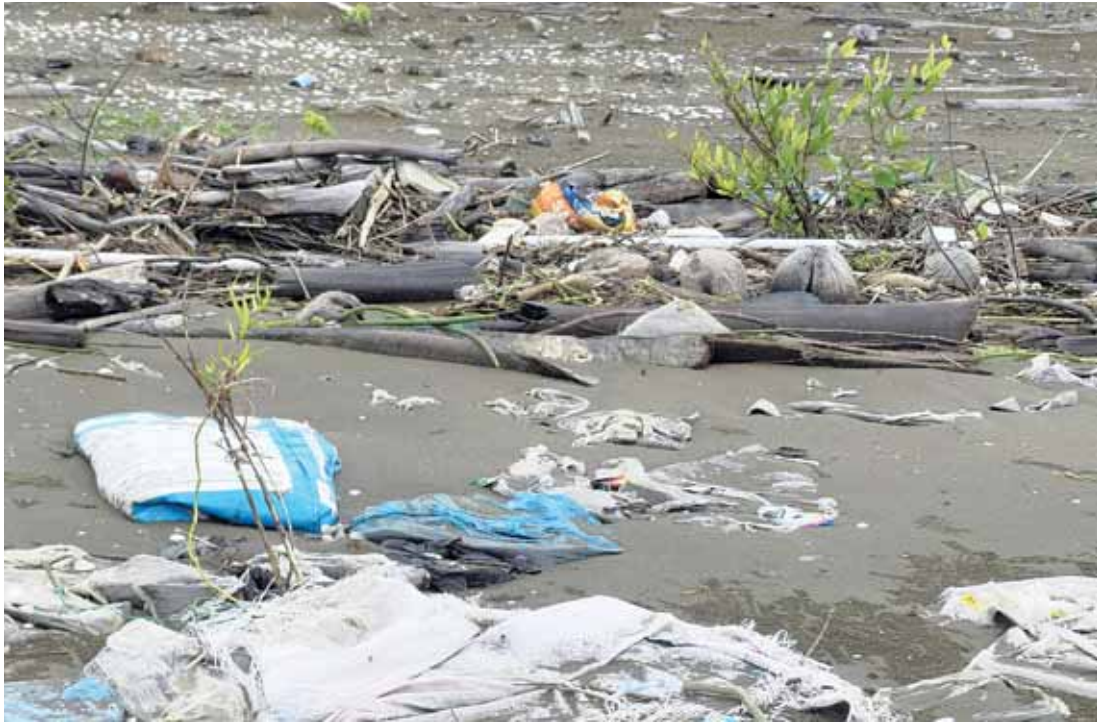
Figure 40: Many mangrove species were found naturally growing well on entrapping micro-sites that consisted of plastic rubbish, dried tree branch and leaves on Den Chop actively eroding area of An Thuy commune, Ba Tri District. Ben Tre, Vietnam, Phong Nguyen, IUCN Ben Tre Project, 2014

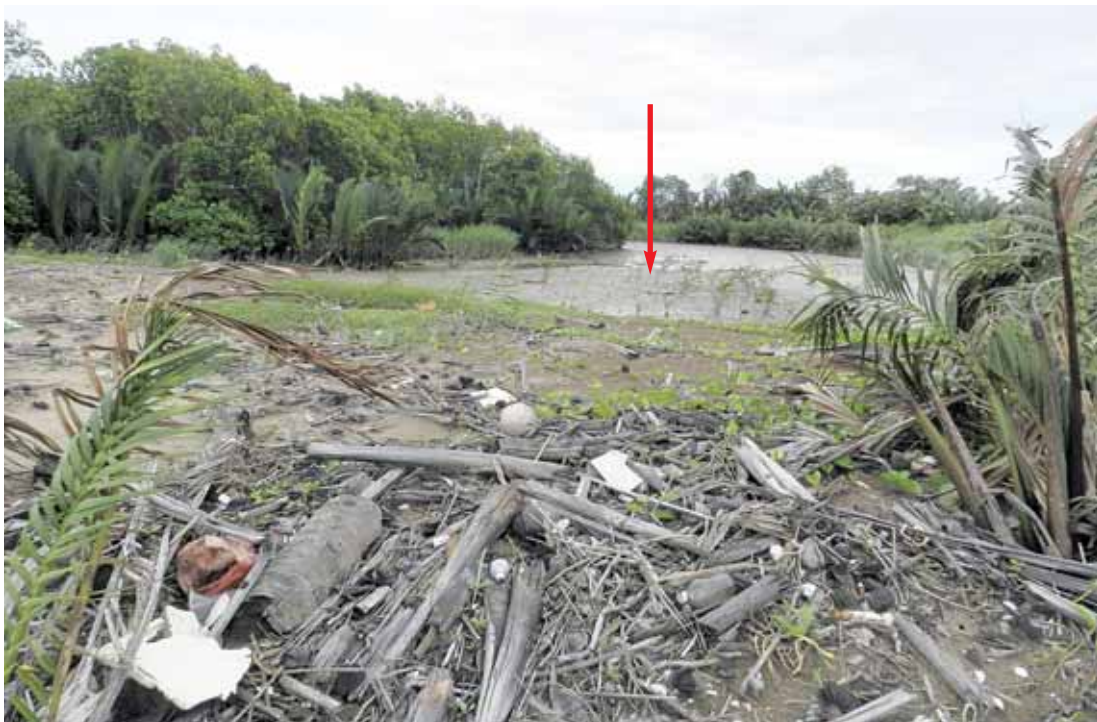
Figure 41: A large area where many mangrove trees are naturally regenerated was found on Den Chop actively eroding area of An Thuy commune, Ba Tri District. Ben Tre, Vietnam, Phong Nguyen, IUCN Ben Tre Project, 2014
